CONTINENTAL INSTRUMENTS LLC
A NAPCO SECURITY GROUP COMPANY

Tech Note #: TN-49

Subject: Trilogy Network Locks used with Expanders might require a firmware download prior to the installation on the door

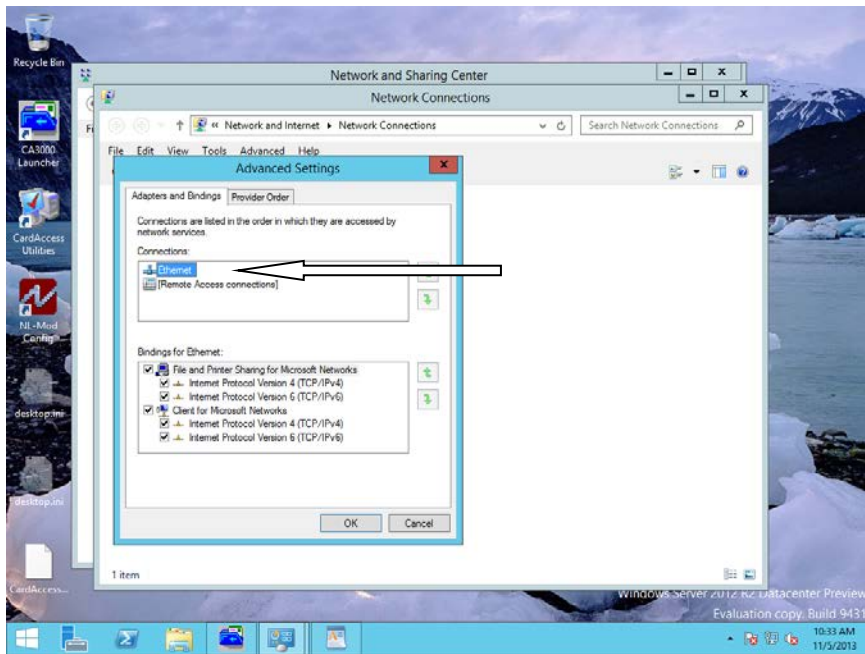
Below are a few reasons why this might occur:

- The CardAccess 3000 host and the Networx Gateway are on different subnets.
- The active network adaptor is not the first adaptor in the Adapter/Binding list. Set the active Ethernet connection to the first in the Adapter/Binding list. Refer to the figure below.

Note: Navigating to this screen will vary depending on the operating system you are using. Once you are at this screen, you must put the active Ethernet connection on the top of the bindings (connections) list.

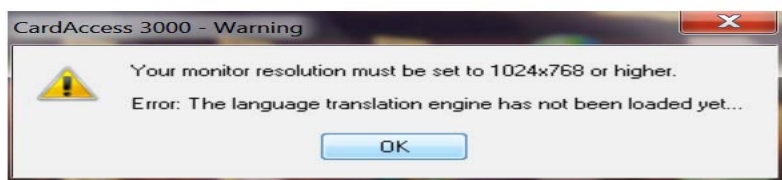
Figure 1.

The minimum screen resolution for the CardAccess 3000 software is 1024 X 768. While at this resolution, an error might display if the **size of text** is set to **Larger 150%** under Display settings. Refer to figure 1 for the error message.

Under Control Panel>Display, configure the **size of text** to **Smaller 100%**.

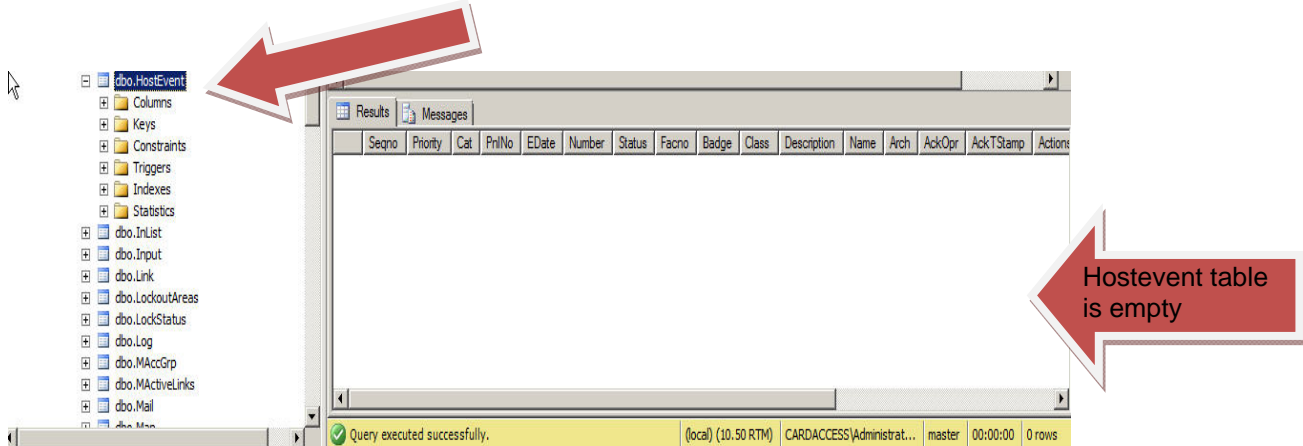
Figure 1.

The “ca3000 DatabaseTask” service is responsible to move the alerts from the “hostevent” table to the “Event” table (Event grid). If the “ca3000 DatabaseTask” service is not started or does not have the correct permissions, the alerts will never move from the “hostevent” table and appear to be missing.

1) Verify if there are any stuck alerts in the “hostevent” table. Using the SQLServer Management Studio, view the “hostevent” table. The “hostevent” table should be emptied every few seconds. In the example below, the “hostevent” table is empty. Refer to figure 1. If there are multiple alerts stuck in this table, continue on with the following steps.

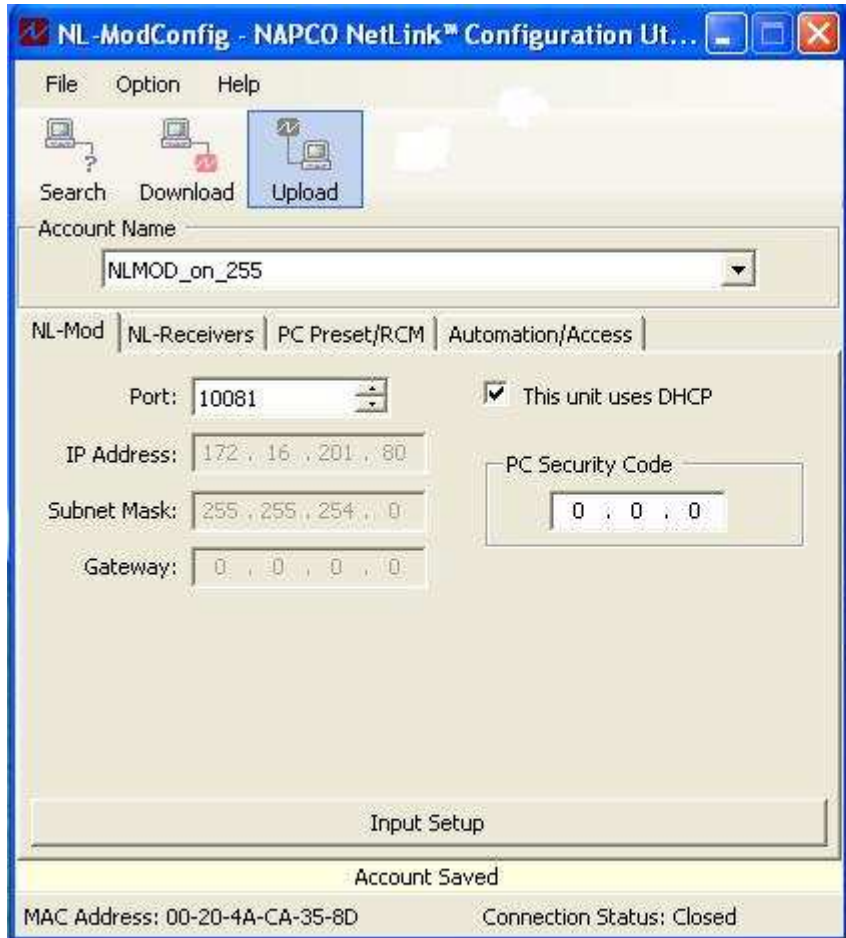
Issue: With the release of ICD293-1.6.203 on March 23, 2011 a problem was introduced involving the defaults used in this product. This caused the NL-Mod-UL to make repeated attempts to connect to the Napco NL-RCM server, an impossible task considering that no NL-RCM board exists in the product. As a result, attempts to connect to the NL-Mod-UL would result in an approximate 80% failure rate.

Symptoms and Indications: Units having this problem are labeled with either a triangle 1 or triangle 2. Symptomatically, the red LED on the unit will remain lit for approximately 80% of the time. Attempts to connect to the unit using NL-Mod Config will often result in a failure to connect. If used with Continental Napco Integration, all operations will appear sluggish and slow to respond.

Correction Method: This problem is field correctable. It involved connecting to the NL-MOD-UL with NL-Mod-Config, uploading the current state from the NL-MOD-UL, removing the offending connection to the NL-RCM server and downloading the changed account back to the NL-MOD-UL. Proceed as follows:

1. Using NL-MOD-CONFIG ver. 3.0.1.27 or later, select the account representing the NL-MOD-UL to be fixed and UPLOAD.

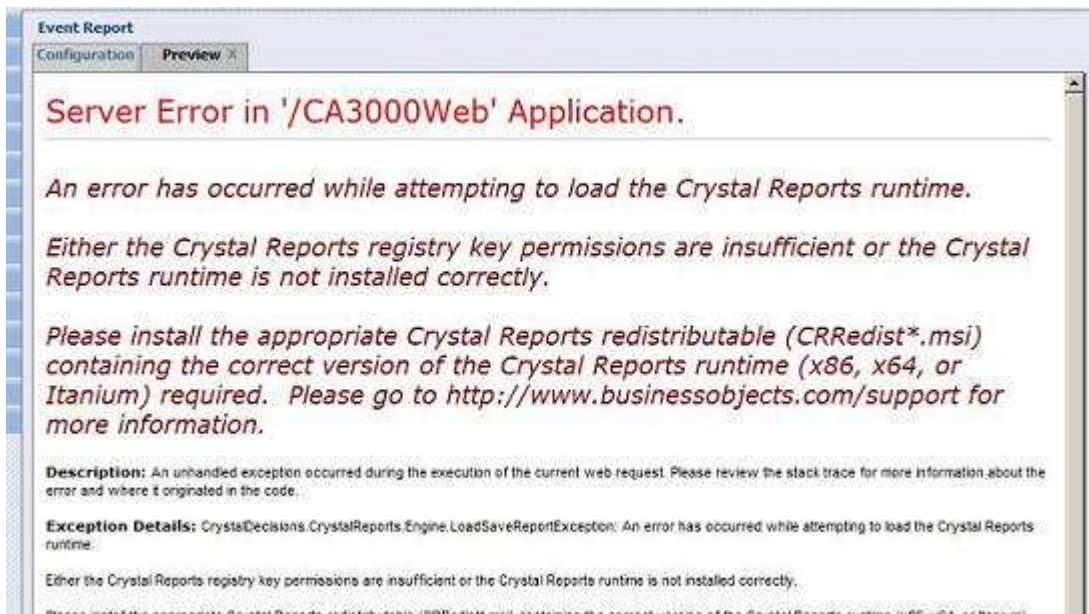
Figure 1.

The Web Client displays an error while running reports on a 64 bit computer. Refer to figure 1.

Install the CRRedist2008_X86.exe (32 bit version of Crystal Reports). This file can be found on the production DVD in the "WebInterface/CrystalReports10_5" folder.

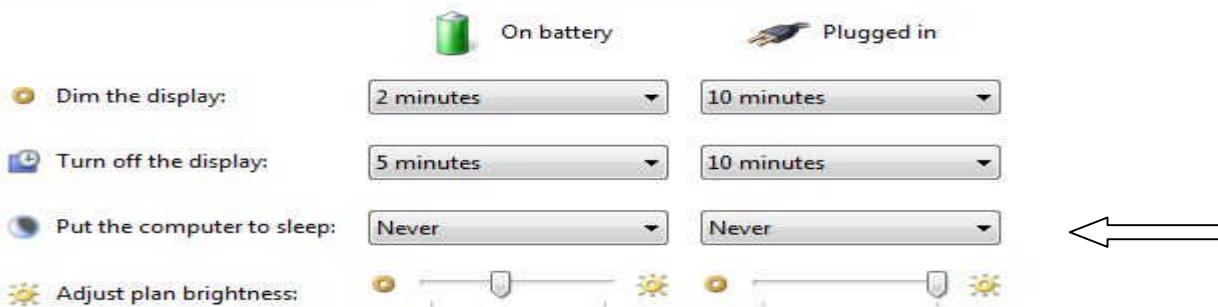
Figure 1.

The activation of sleep mode can cause the cicdataserver and hostnt.exe to terminate. This will result in the loss of communications to the panels.

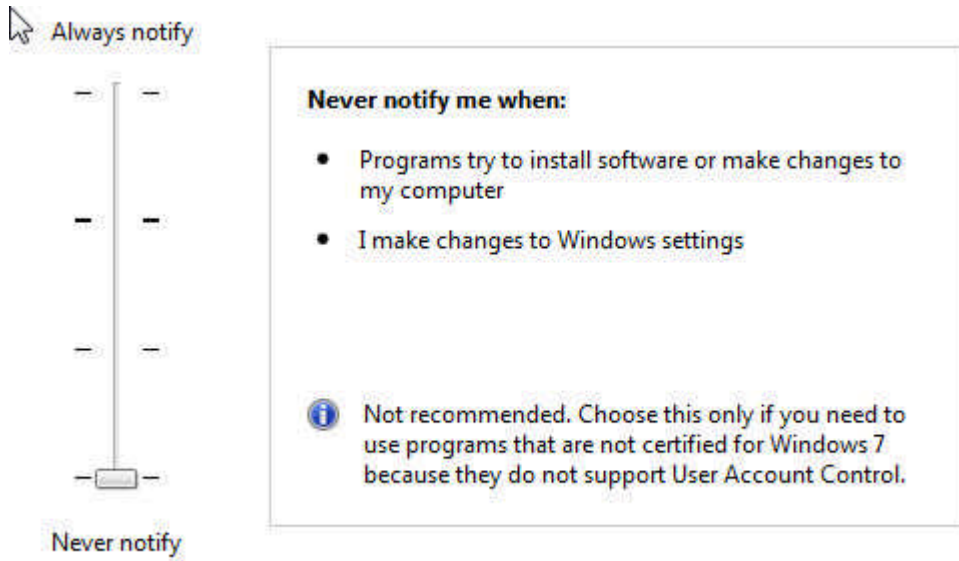
Figure 1.

It is recommended to lower or disable the UAC settings prior to installing the CardAccess 3000. Failure to lower or disable the UAC settings will result in problems executing the CardAccess 3000 utilities. The procedure is different for Windows 7 Pro and Server 2008.

- 1) Click **Start** and then click **Control Panel**
- 2) Click **User Accounts**
- 3) Click **Change User Account control settings**
- 4) Slide the bar down to **Never Notify** as per the figure 1.
- 5) Click **OK**

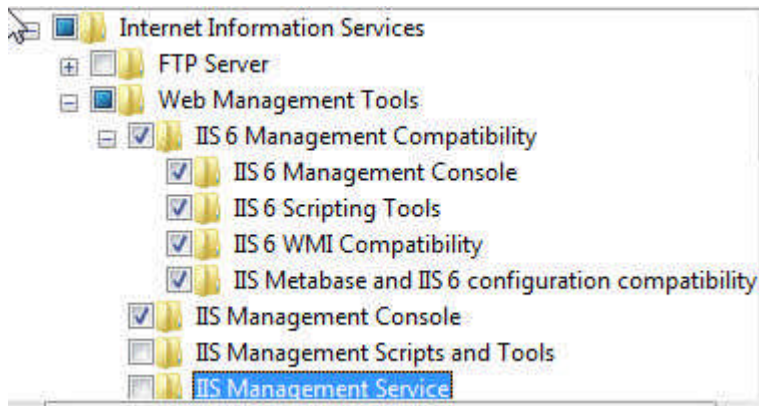
Figure 1.

The CA3000 web Interface fails during the installation. During the installation, an error message will display. The message will be similar to “The installer has been interrupted”. To correct this problem, refer to the following steps. The fix will be different depending on your operating system.

1. Click Start/All Programs/Control Panel
2. Click “Program and Features”
3. Click “Turn Windows features on or off “. A list will populate with all the features.
4. Configure the settings for “Internet Information Services” as per figure 1.
