CONTINENTAL INSTRUMENTS LLC
A NAPCO SECURITY GROUP COMPANY

Tech Note #: TN-49

Subject: Trilogy Network Locks used with Expanders might require a firmware download prior to the installation on the door

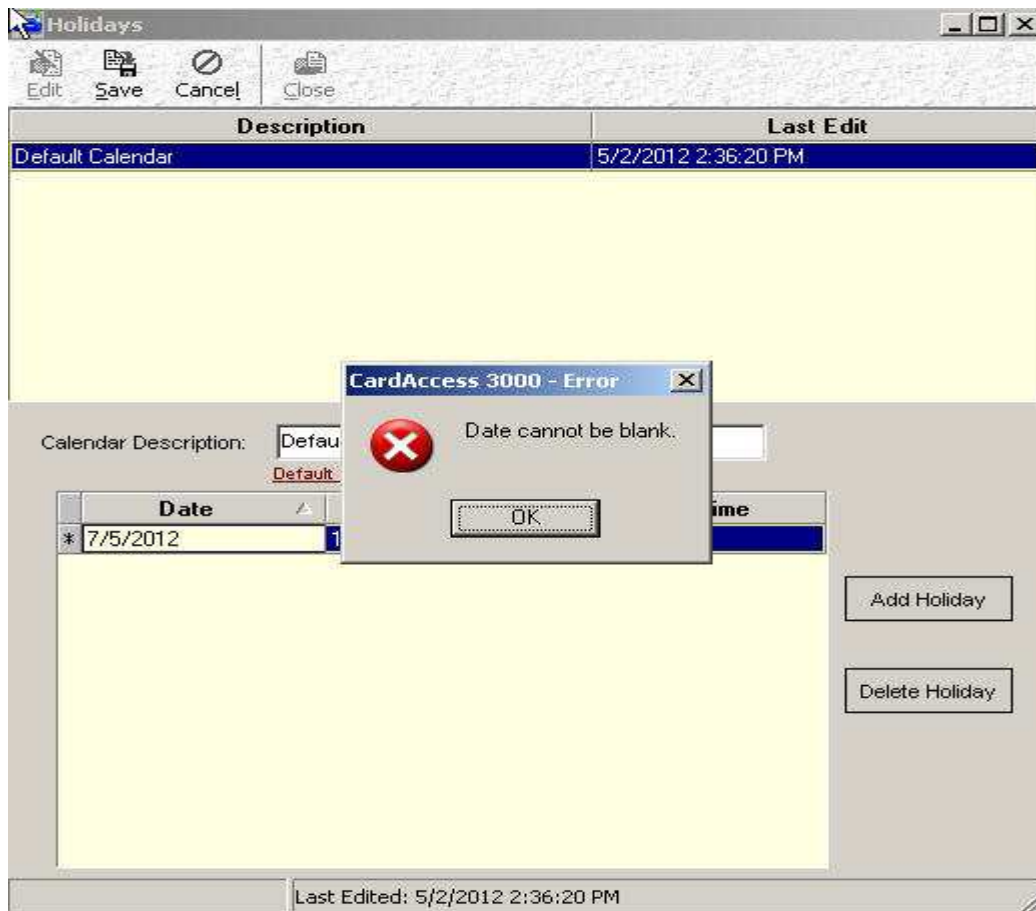
Figure 1.

Scenario # 1 - While selecting and saving a date with the calendar control.

Scenario # 2) – While deleting all holidays from the calendar list.

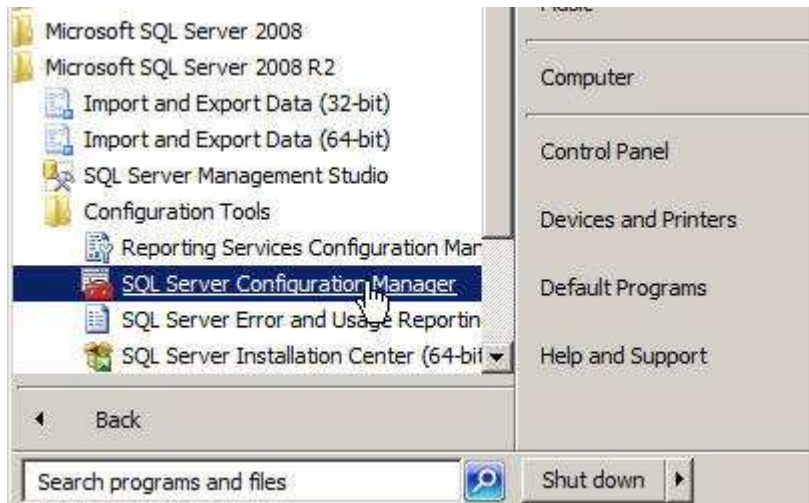
Figure 1.

1) Click on the **SQL Configuration Manager**. The SQL Configuration Manager can be executed from the Start button (Refer to figure 1).

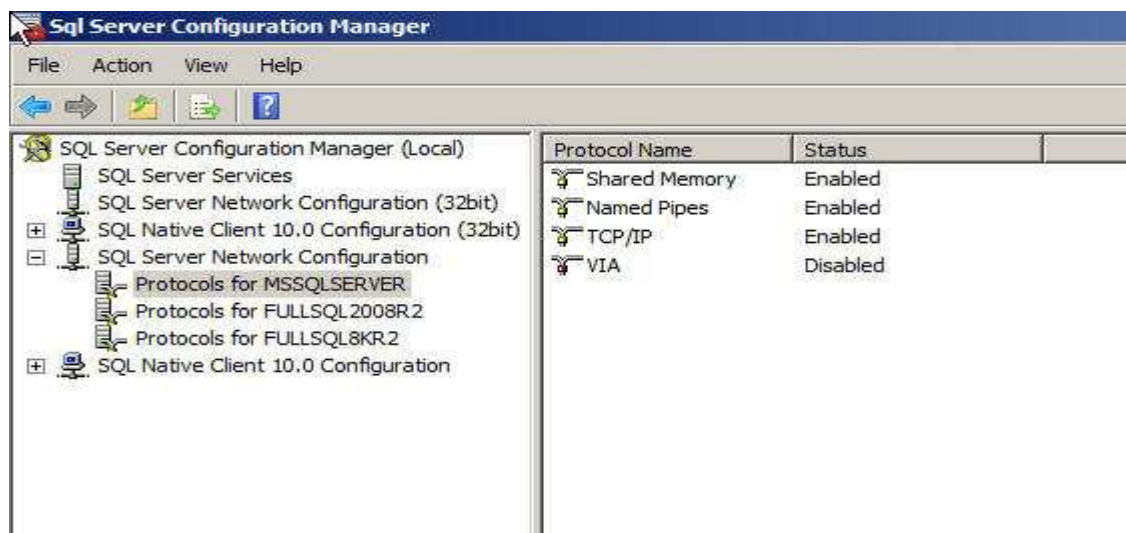
Figure 2.

2) Verify the protocols are enabled for the instance of SQL you installed. The protocols are under “SQL Server Network Configuration”. You must verify “Shared Memory”, Named Pipes” and “TCP/IP” are enabled (Refer to figure 2.)

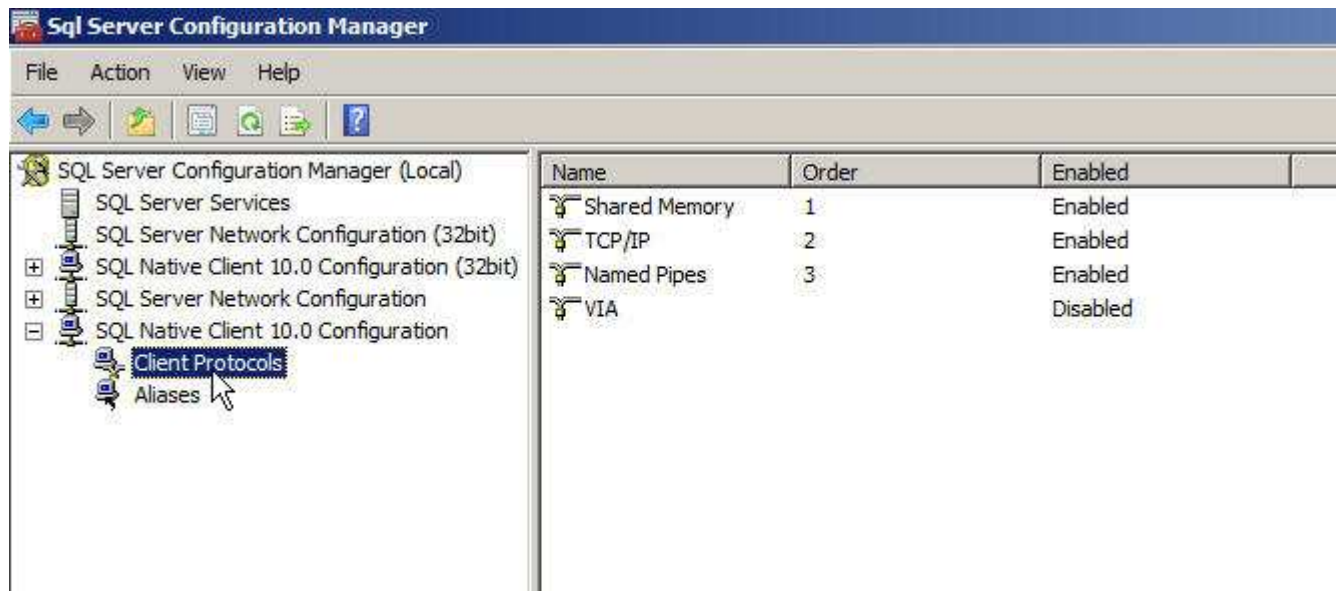
Figure3.

3) Verify the protocols are enabled for the **SQL Native Client (Client Protocols)**. Verify the “Shared Memory”, Named Pipes” and “TCP/IP” are enabled (Refer to figure 3.)

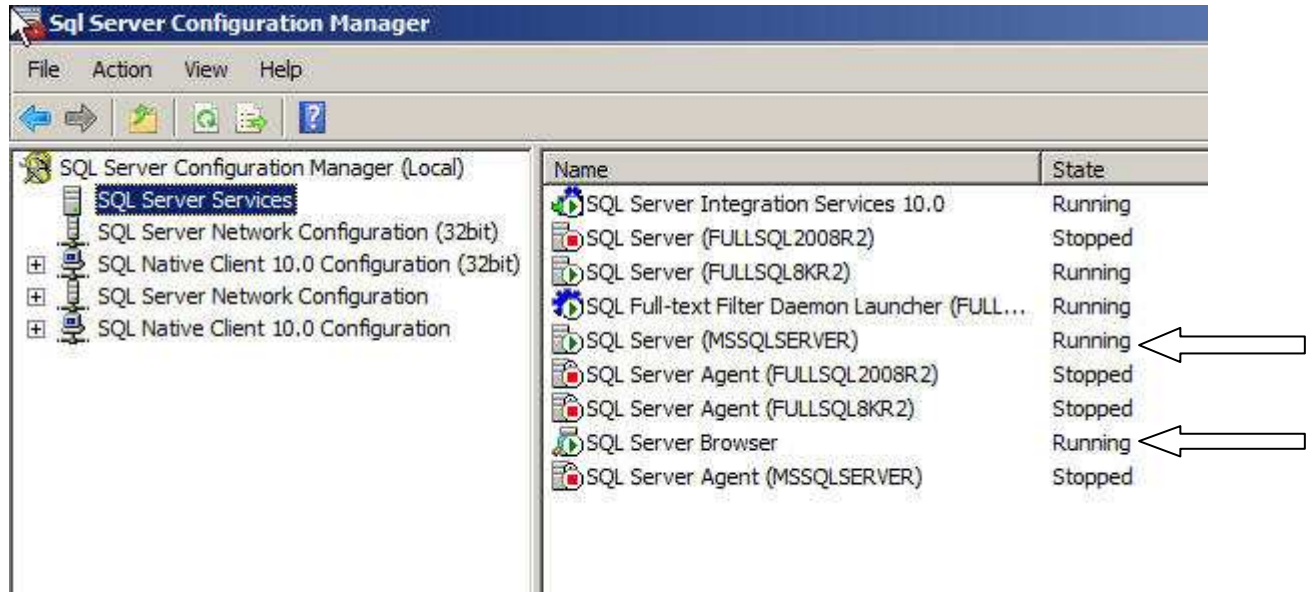
Figure 4.

3) Using the SQL Server Configuration Manager, verify the **SQL Server Instance** that was installed is “Running” and the **SQL Server Browser** is “Running” (Refer to figure 4).

Note: In the screen shot below, the “SQL Server (MSSQLSERVER)” is the instance installed.

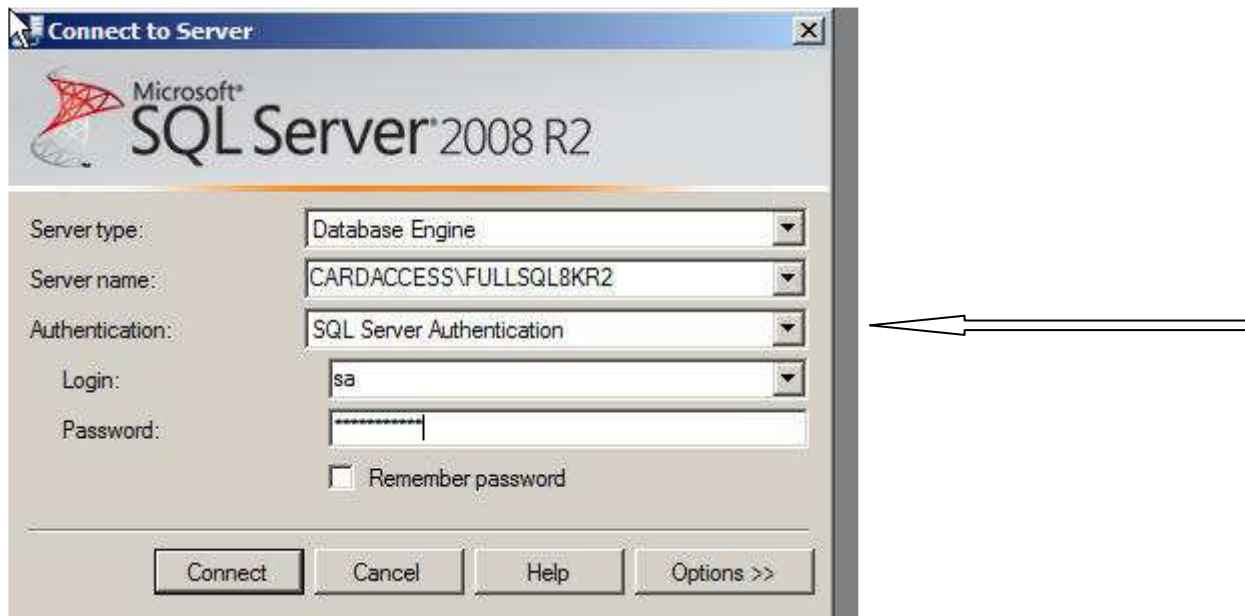
Figure 5.

5) After the SQL Server Management studio is loaded, verify you can log into SQL using the “sa” and “cic” user. Set the “**Authentication**” to “**SQL Server Authentication**” mode to perform these tests (Refer to figure 5).

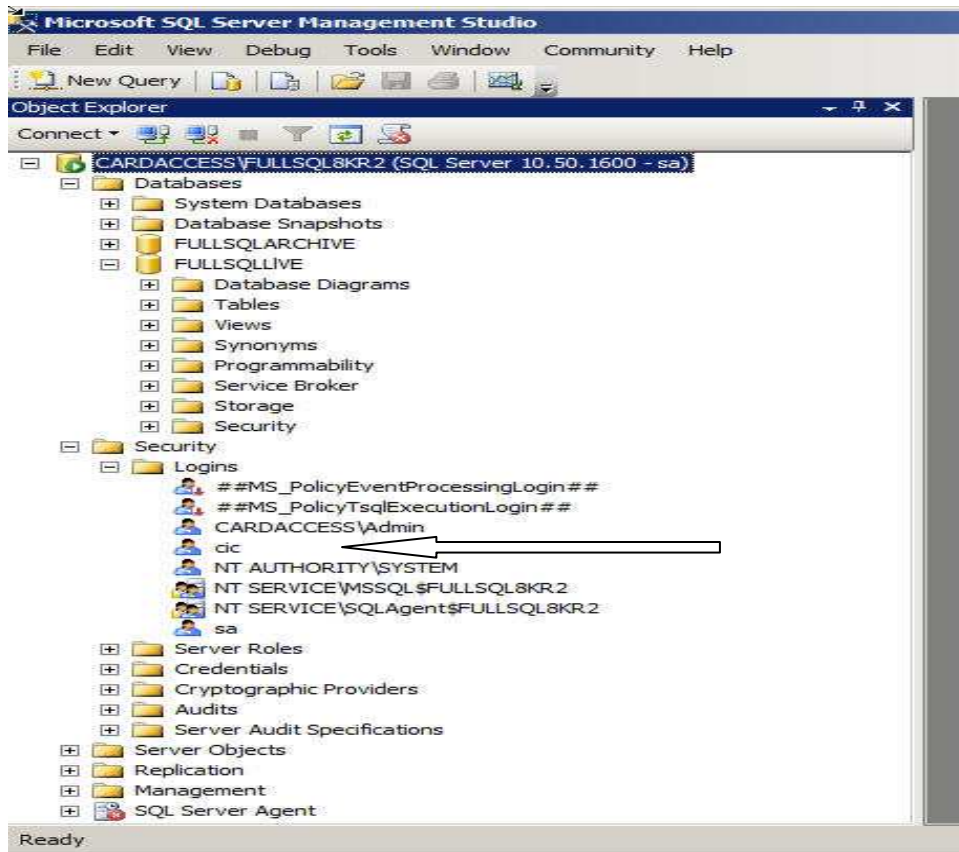
Figure 6.

6) If you are unable to log in with the “cic” user, use the **SQL Management Studio** and log in with “sa”. Verify the “cic” user login is configured (Refer to figure 6).

Note: The “cic” user is a user created by CardAccess 3000 software. This user might not be configured until you create a database using the CardAccess utility.
