Introducing the **Thermally Broken** Roof Hatch, the New Standard in Energy Efficiency

Thermally Broken Roof Hatch

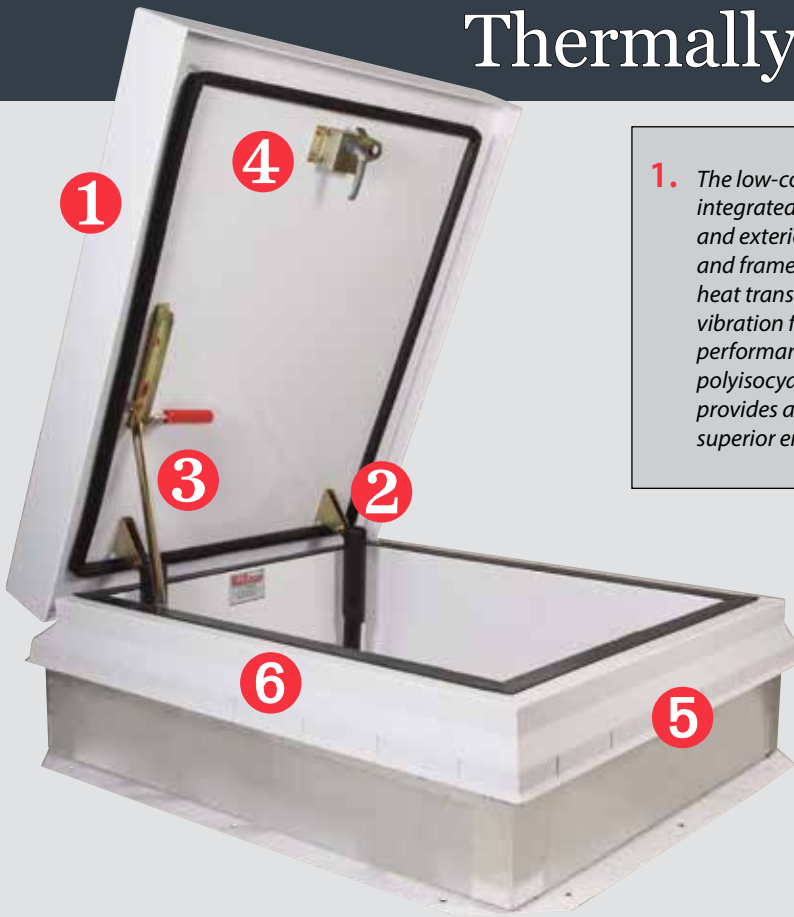
1. The low-conductivity element integrated between the interior and exterior surfaces of the cover and frame not only reduces heat transfer, but also dampens vibration for improved acoustic performance, while the 3" of polyisocyanurate insulation provides an R-value of 18 for superior energy performance.
